# SELF INSPECTION SHEET

TUE	CAR	OPERATOR NAME	DATE	SELF INSPECTION NUMBER	PAGES
TS228	M3	Fikile MBONANI	13/05/2024	SI.FT1040.22	01/08

SELF INSPECTION INDUSTRIAL QUALITY	Rev. 02 DATE- 2022/06/22	Project: PRASA	SI.FT1040.22

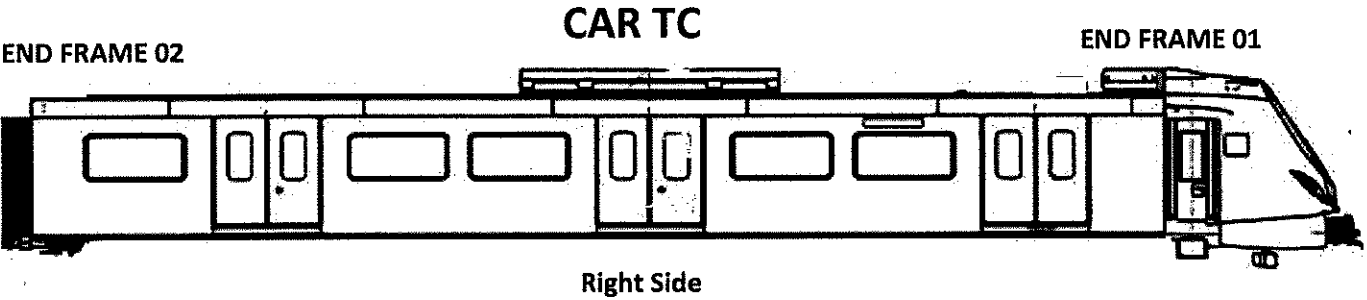
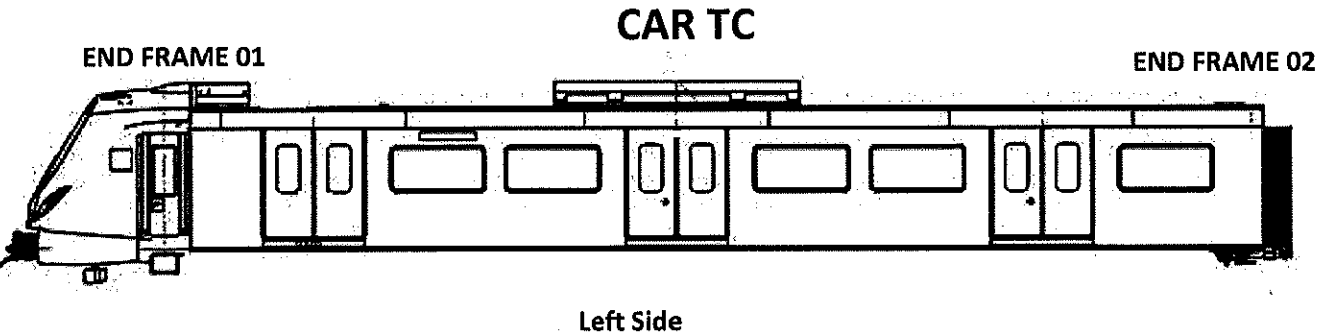
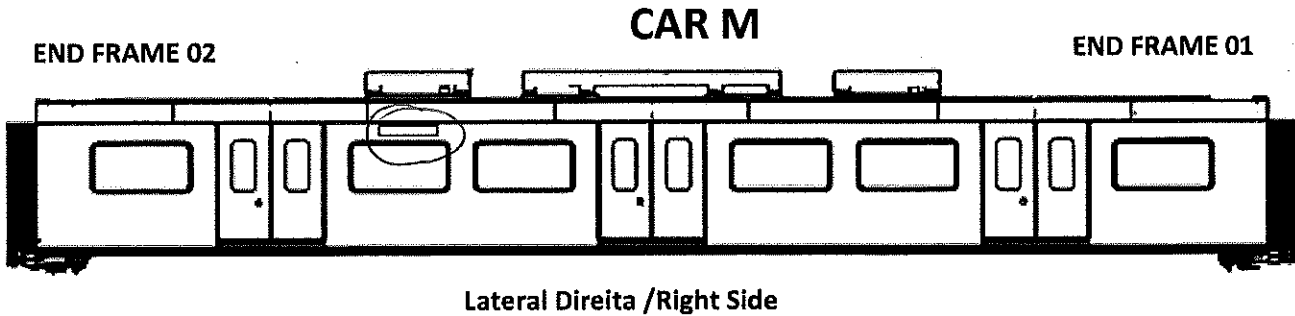
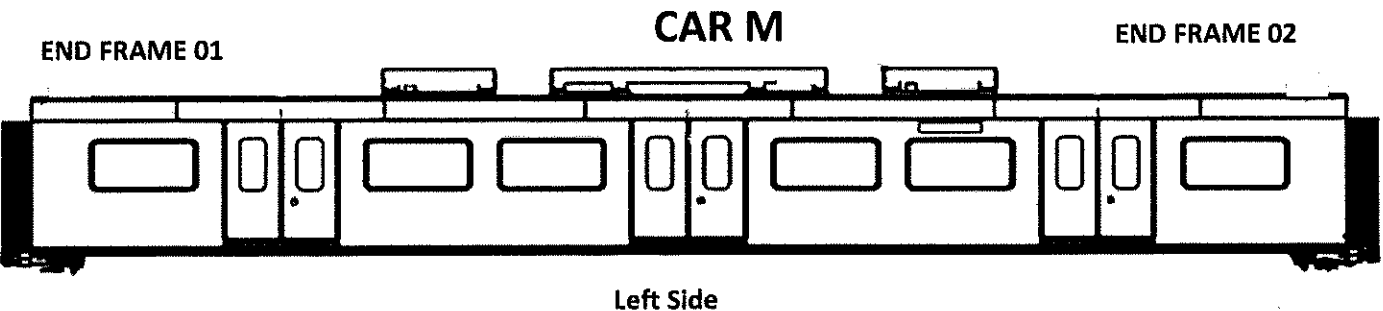
<b>SELF INSPECTION INDUSTRIAL QUALITY</b>		Rev. 02	Project: PRASA	SI.FT1040.22
				DATE- 2022/06/22		
ITEM	NP Leakages	Description/leakages and correction of action	OK			Signature/Date
11	1	LEAK ON RIGHT LATERAL WINDOW.

13/05/2024
		CORRECTIVE ACTION IS TO RE-SEAL.

RHS LATERAL WINDOW LEAK , ~~NEEDS~~ SEALANT NEEDS TO BE RE-APPLIED.
