SELF INSPECTION SHEET

TUE	CAR	OPERATOR NAME	DATE	SELF INSPECTION NUMBER	PAGES
TS22S	TC2	FIRILE MBONANI	09/05/2024	SI.FT1040.22	01/08

<h2 style="margin: 0;">SELF INSPECTION INDUSTRIAL QUALITY</h2>	Rev. 02	Project: PRASA	<h1 style="margin: 0;">SI.FT1040.22</h1>
		DATE- 2022/06/22

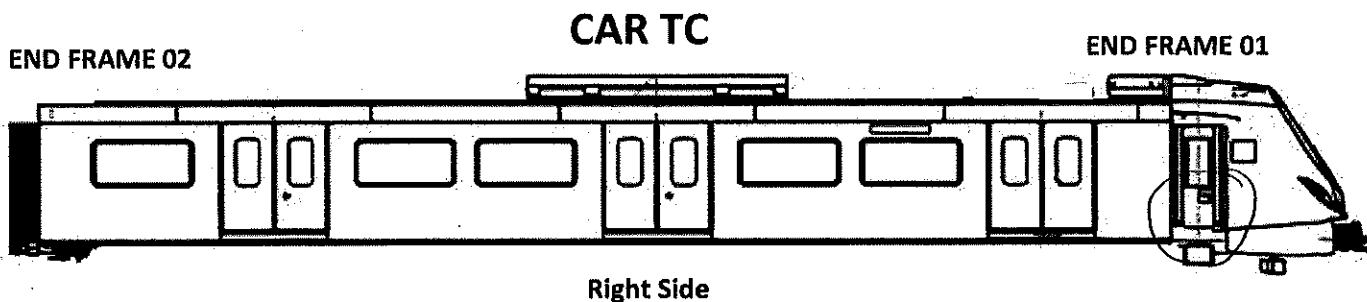
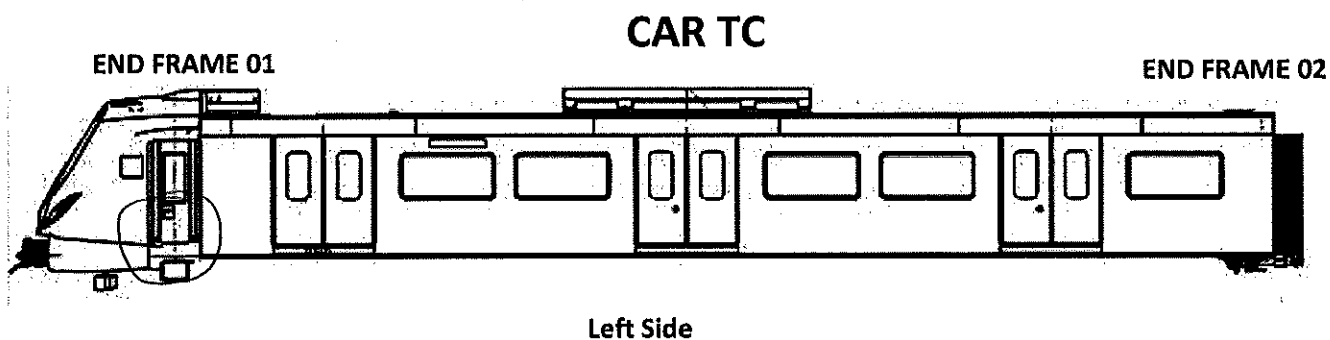
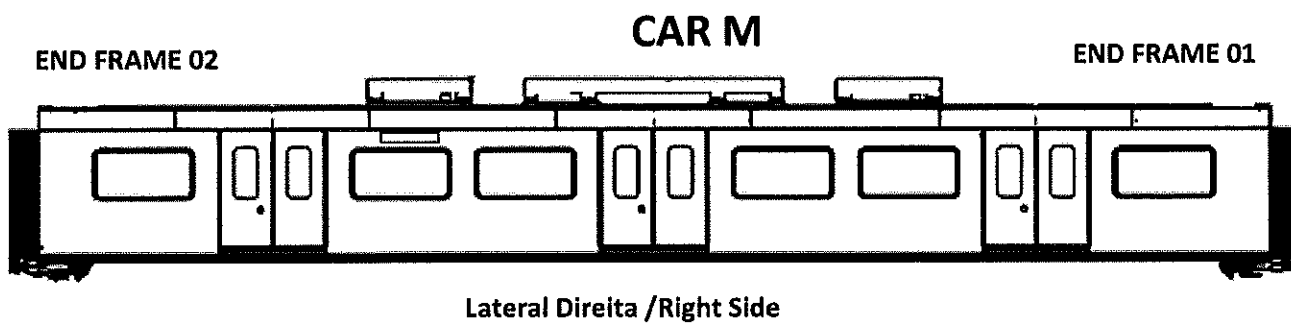
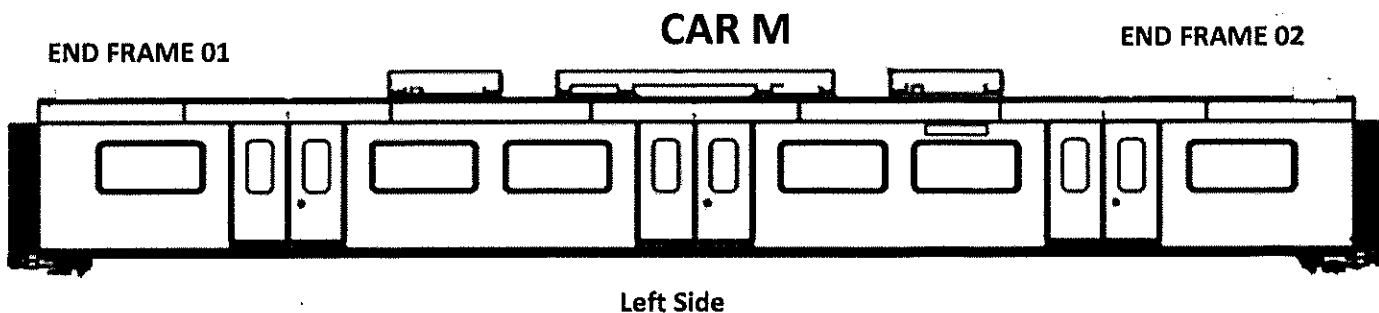
TC	M1 and M2	M3 and M4
-----------	------------------	------------------

SELF INSPECTION INDUSTRIAL QUALITY		Rev. 02 DATE- 2022/06/22	Project: PRASA	SI.FT1040.22
ITEM	DP LeafPages	Description (leakages and corrective action)	OK			Signature/Date
11	1	RHS & LHS CAB DOORS LEAKING.				
		CORRECTIVE ACTION IS TO RE-ALIGN DOOR				
		AND ALSO ALIGN / STRAIGHTENING CAB				
		STRUCTURE.	✓
