SELF INSPECTION SHEET

TC1	M4	M1	M2	M3	TC2		
<input checked="" type="checkbox"/>	DTR3-PROCE-06	INTERNAL WATERTIGHTNESS	FT1040	1	1	1	1	X	1	PRA.FT1040.05.V6	NO
<input type="checkbox"/>											
<input type="checkbox"/>											
<input type="checkbox"/>											
<input type="checkbox"/>											
<input type="checkbox"/>											
<input type="checkbox"/>

TUE	CAR	OPERATOR NAME	DATE	SELF INSPECTION NUMBER	PAGES
TS231	M3	FUKILE MBONANI	11/06/2024	SI.FT1040.22	01/08

<h2 style="margin: 0;">SELF INSPECTION INDUSTRIAL QUALITY</h2>	Rev. 02	Project: PRASA	<h1 style="margin: 0;">SI.FT1040.22</h1>
		DATE- 2022/06/22

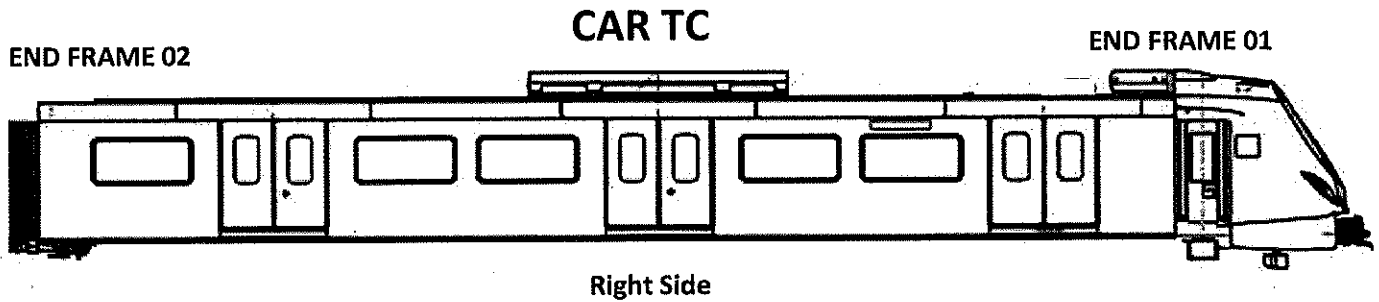
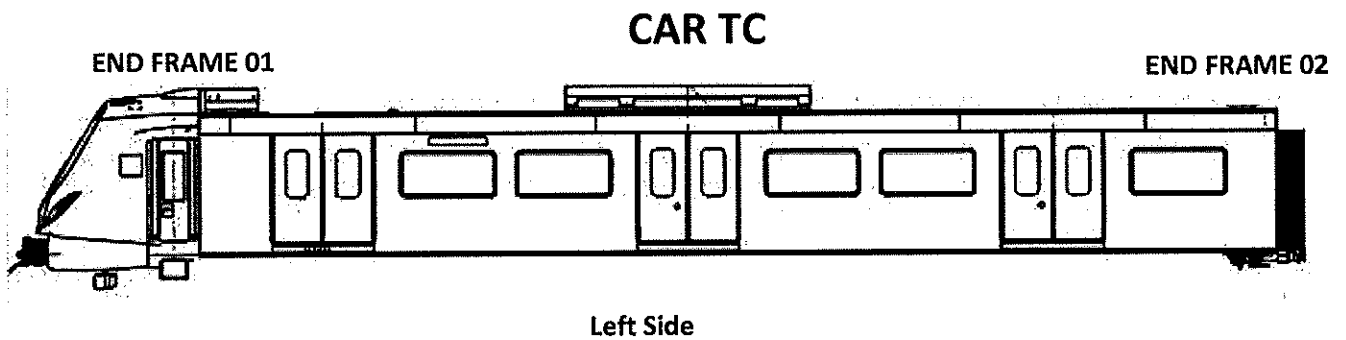
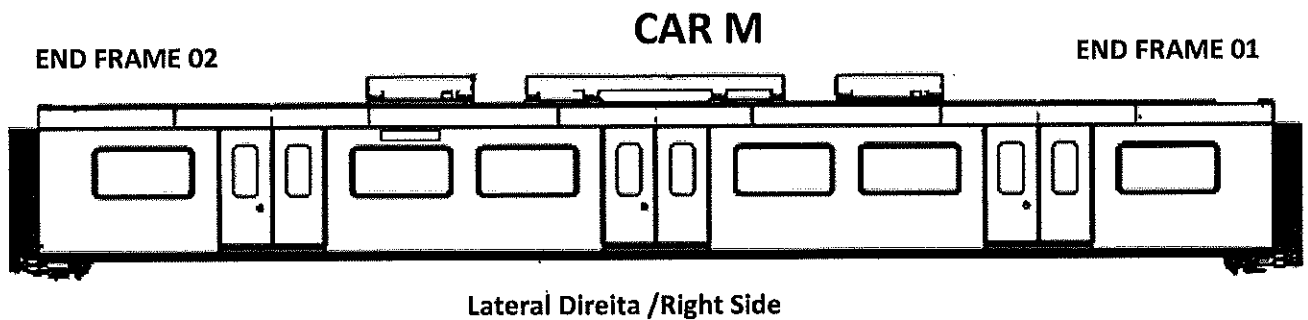
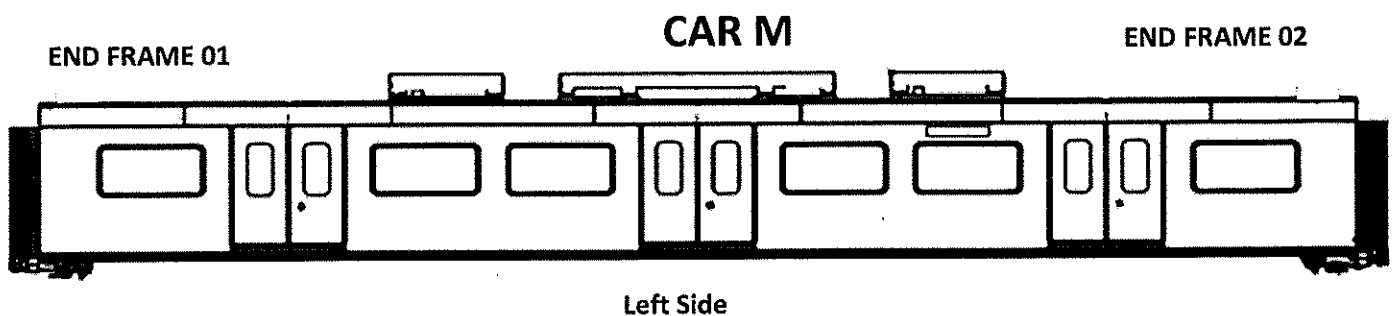
SELF INSPECTION INDUSTRIAL QUALITY		Rev. 02	Project: PRASA	SI.FT1040.22
				DATE- 2022/06/22		
ITEM	Nº Leaks	Description leakages and correction of action	CIC			Signature/Date
11		WATER LEAK ON PASSENGER DOOR 3

11/06/2024
		AND DOOR 5 UPPER GUIDE RAIL				
		BOLTS,

WATER LEAKS ON UPPER GUIDE RAIL BOLTS ON DOOR 3 & DOOR 5.

Item	Description	Action	Responsible	Due Date	Status
1	leak on upper guide rail Bolts door 3 and door 5	remove detached sealant and re-seal	Mpusana	12/06/24	Closed
