SELF INSPECTION SHEET

TUE	CAR	OPERATOR NAME	DATE	SELF INSPECTION NUMBER	PAGES
TS 233	M2	FIKILE MBONANI	20/06/2024	SI.FT1040.22	01/08

<h1 style="margin: 0;">SELF INSPECTION INDUSTRIAL QUALITY</h1>	Rev. 02	Project: PRASA	<h2 style="margin: 0;">SI.FT1040.22</h2>
		DATE- 2022/08/22

Work station: FT1040

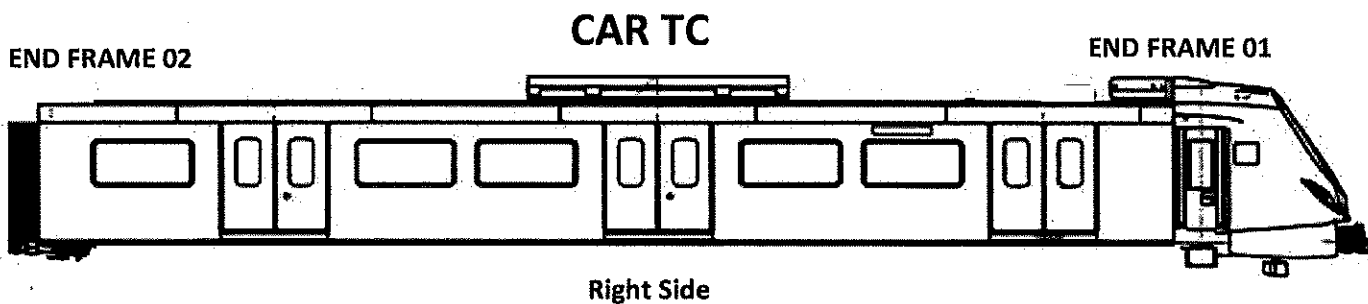
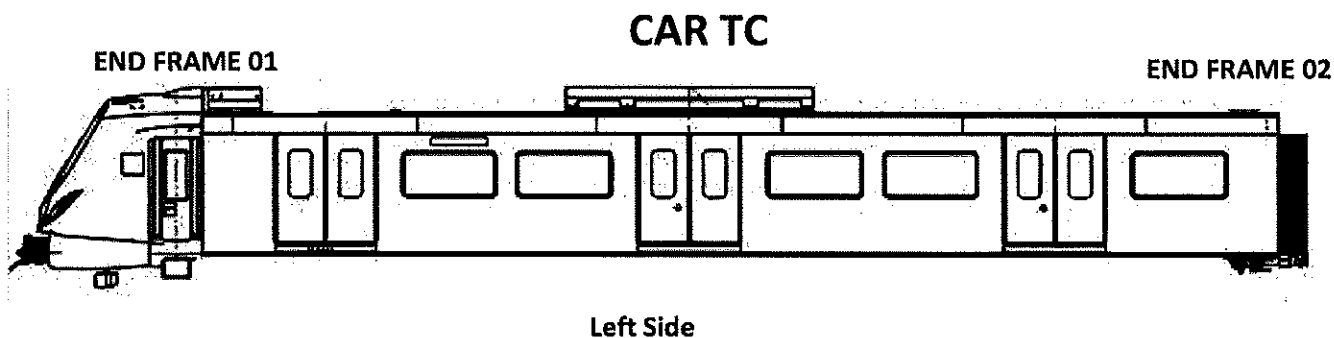
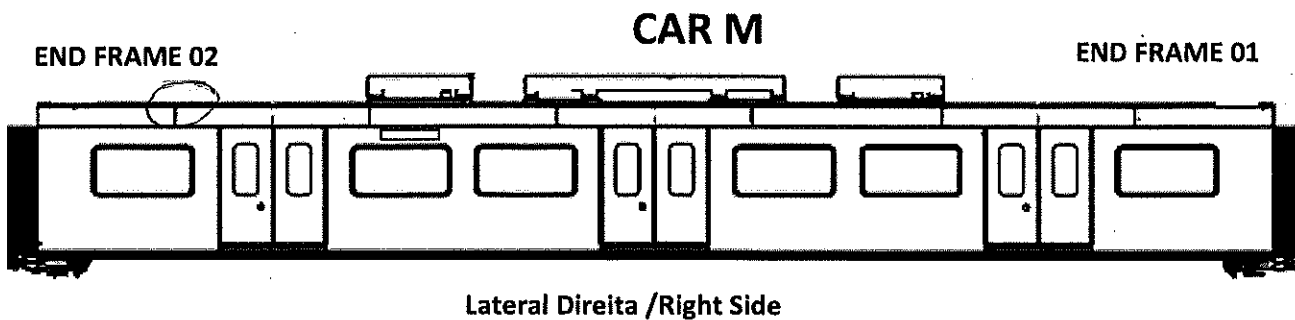
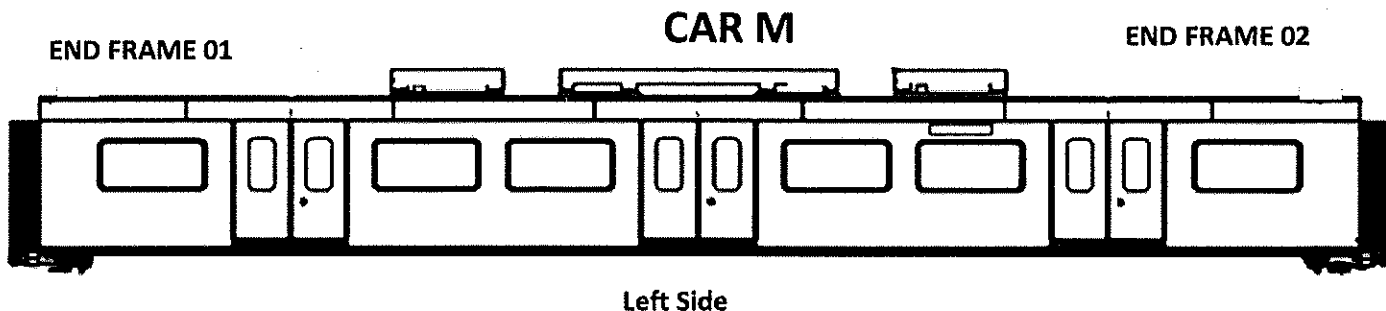
SELF INSPECTION INDUSTRIAL QUALITY		Rev. 02 DATE- 2022/06/22	Project: PRASA	SI.FT1040.22
ITEM	Nº Leaks	Description leaks and correction of action	OK			Signature/Date
11	1	LEAK FROM THE ANTENNA PLATE, NEEDS TO APPLY SEALANT ON PLATE TO COVER OPEN GAP	✓

Item	Description of the Issue		Signature/Date
1	LEAK ON ANTENNA PLATE	✓

In case of "NO GO", describe blocking problems					
LEAK ON ANTENNA PLATE FROM THE ROOF., NEEDS RE-APPLICATION OF SEALANT ON THE PLATE.					
In case of "NO GO", the operations manager must define below action plan to ensure "GO":
