# SELF INSPECTION SHEET

MOUNTING		DESCRIPTION	STATION	CAR TYPE						WORK INSTRUCTION	SAFETY ?

TUE	CAR	OPERATOR NAME	DATE	SELF INSPECTION NUMBER	PAGES
T5234	TC2	FIKILE MBONANI	26/06/2024	SI.FT1040.22	01/08

<h2 style="margin: 0;">SELF INSPECTION INDUSTRIAL QUALITY</h2>	Rev. 02	Project: <b>PRASA</b>	<h1 style="margin: 0;">SI.FT1040.22</h1>
		DATE- 2022/06/22

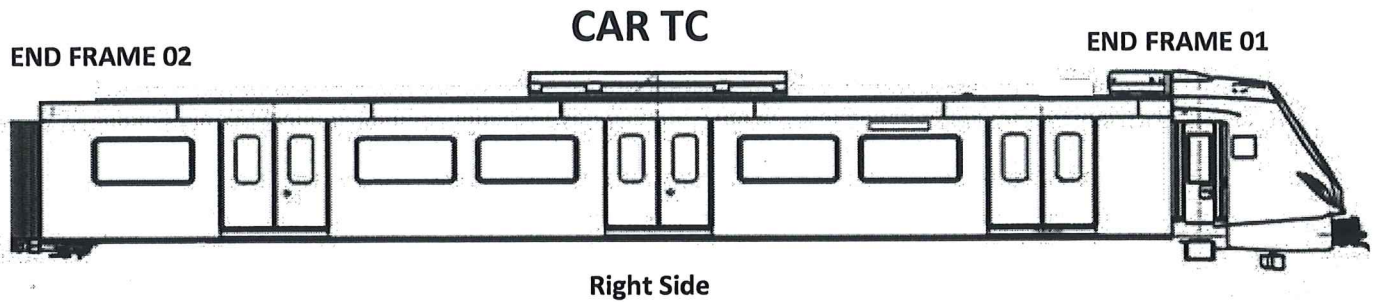
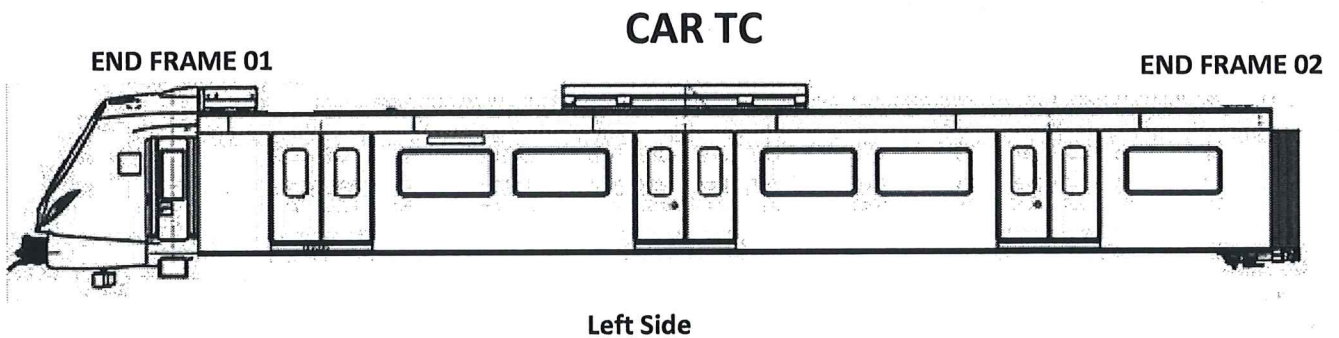
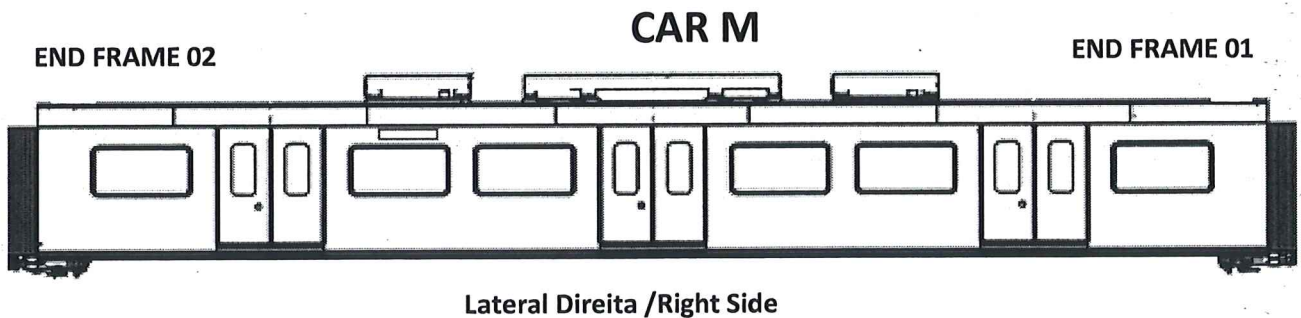
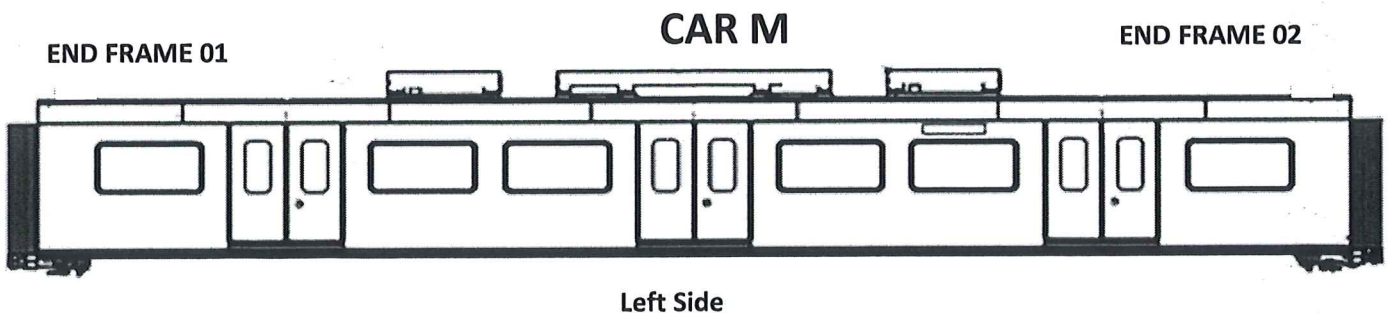
<b>TC</b>	<b>M1 and M2</b>	<b>M3 and M4</b>
-----------	------------------	------------------

<b>SELF INSPECTION INDUSTRIAL QUALITY</b>		Rev. 02	Project: PRASA	<b>SI.FT1040.22</b>	
				DATE- 2022/06/22			
ITEM	Nº Leakages	Description leakages and correction of action	OK	NO	Notwork	Signature/Date	
11	1	LEAK ON DOOR 5 BOLTS (UPPER GUIDE

26/06/2024	
		RAIL). CORRECTION ACTION IS TO					
		RESEAL THE BOLTS.

In case of "NO GO", describe blocking problems <div style="font-size: 1.1em; margin-top: 5px;">             leak on door 5 upper clanking Rails           </div>						
In case of "NO GO", the operations manager must define below action plan to ensure "GO":

Item	Description	Action	Responsible	Due Date	Status	
1	Upper rails leading	remove detached sealant and re-apply	Eddie and William	26/06/24	GO - closed
