SELF INSPECTION SHEET

MOUNTING		DESCRIPTION	STATION	CAR TYPE						WORK INSTRUCTION	SAFETY ?

SELF INSPECTION INDUSTRIAL QUALITY	Rev. 02	Project: PRASA	SI.FT1040.22
		DATE- 2022/06/22

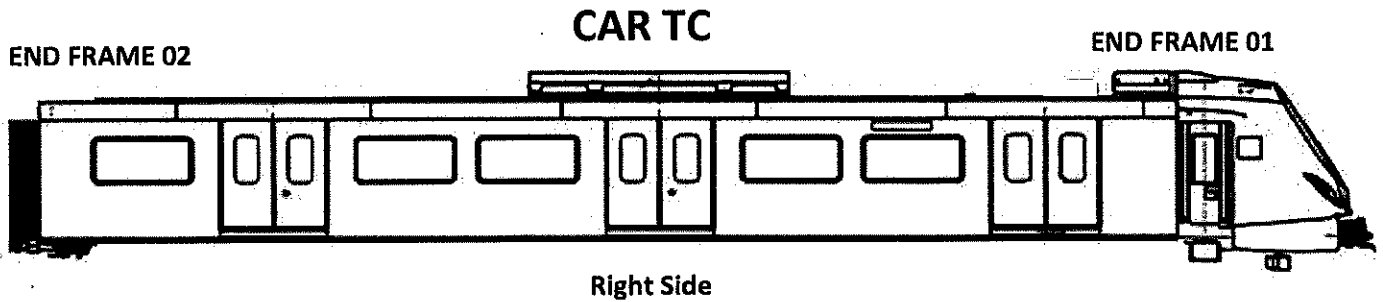
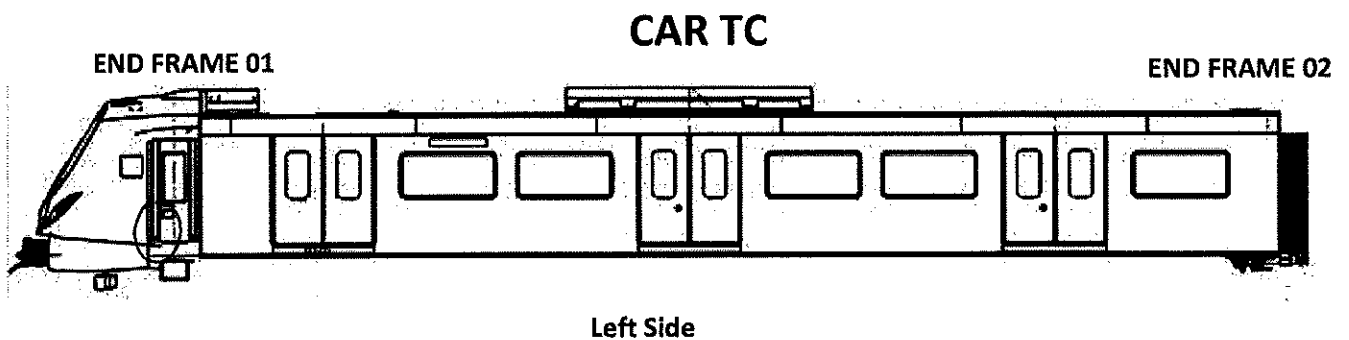
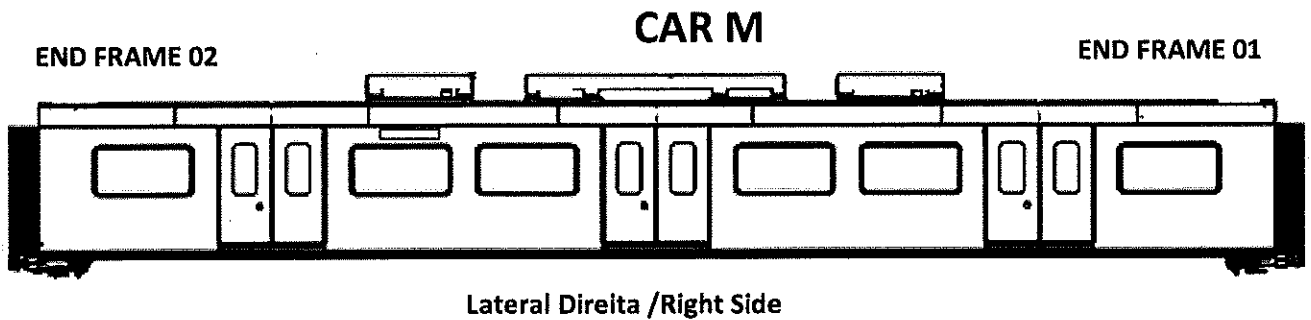
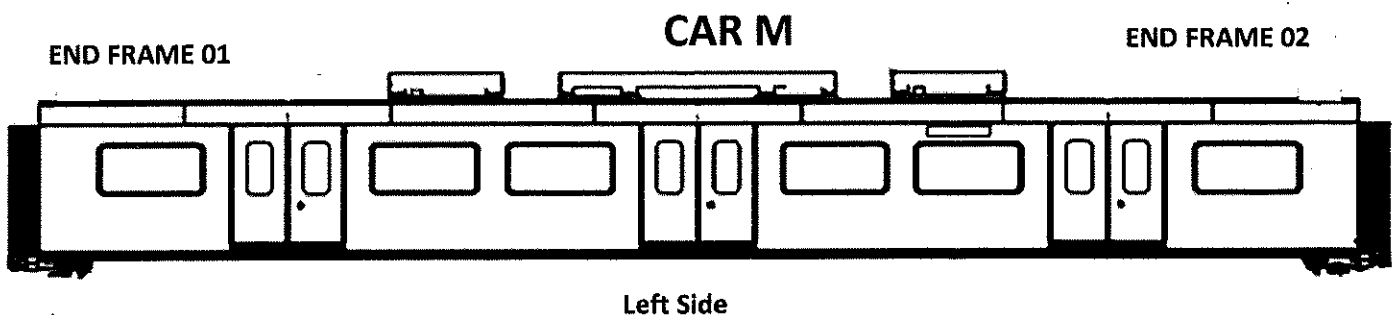
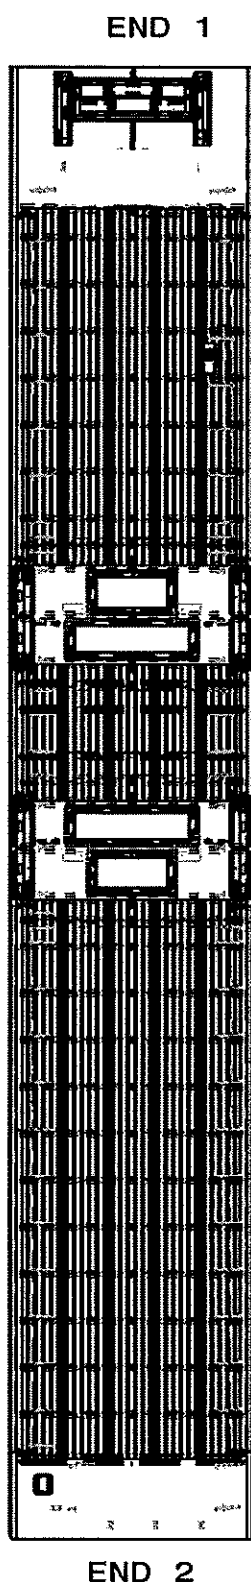
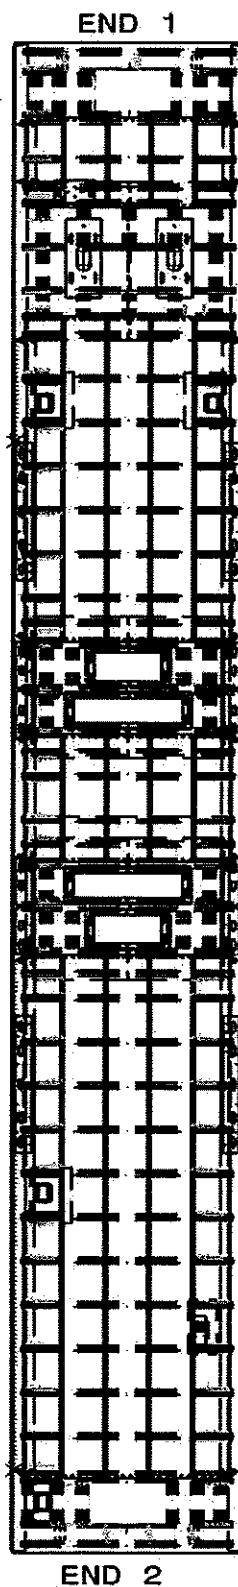
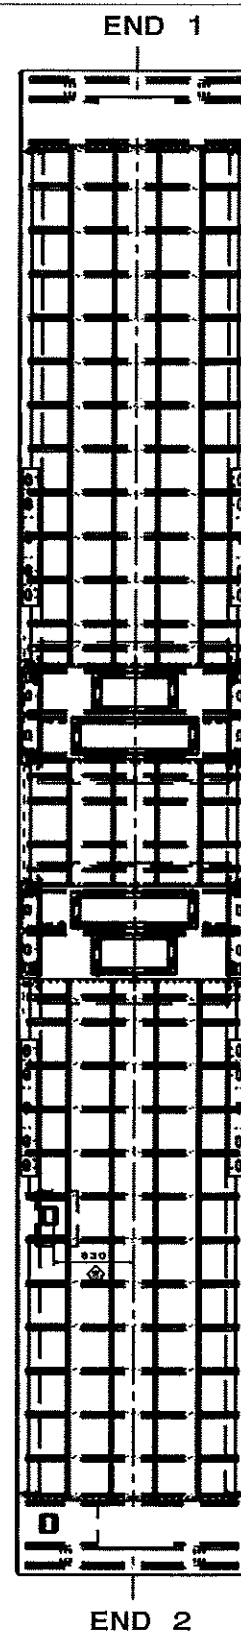
SELF INSPECTION INDUSTRIAL QUALITY	Rev. 02	Project: PRASA	SI.FT1040.22	
			DATE- 2022/06/22			
ITEM	UF Leaks	Description Leaks and correction of action	UF	UF	UF	Signature/Date
11	1	LEAK ON CAB DOOR (LHS),

20/06/2024
		NEEDS ADJUSTMENT OF CAB STRUCTURE				
		FOR A TIGHT SEAL OF THE RUBBER ON				
		THE DOOR.	✓

LEAK ON LHS CAB DOOR.
