PRASA PROJECT

SELF INSPECTION SHEET

TUE	CAR	OPERATOR NAME	DATE	SELF INSPECTION NUMBER	PAGES
TS222	TC2	GOODNESS	09/05/24	**SI.FT1140.52**	01/08

TRAIN SET 222	REF: GIB0000001672_J0 PRASA WEIGHT BALANCE EN
	PC09 WEIGHING REPORT

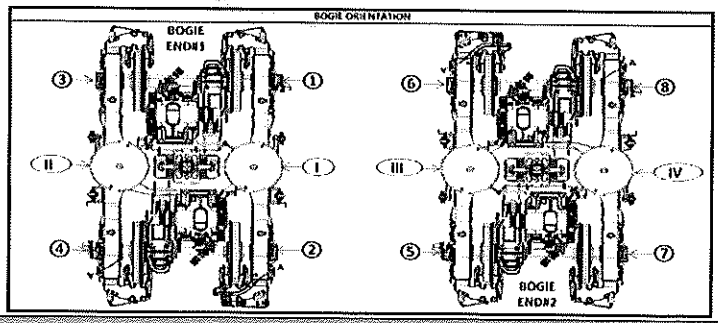
Weighting report from Test and Commissioning (Final measurements after Levelling and Weighting fine)
