SELF INSPECTION SHEET

TUE	CAR	OPERATOR NAME	DATE	SELF INSPECTION NUMBER	PAGES
TS 223	M3	B. Mokoena	17/05/24	**SI.FT1140.52**	01/08

GIBELO	SELF INSPECTION INDUSTRIAL QUALITY	Rev:09 Date: 5/31/2022	Projet: PRASA	SI.FT1140.52

TRAIN SET 223	REF: GIB0000001672_J0 PRASA WEIGHT BALANCE EN
	PC09 WEIGHING REPORT

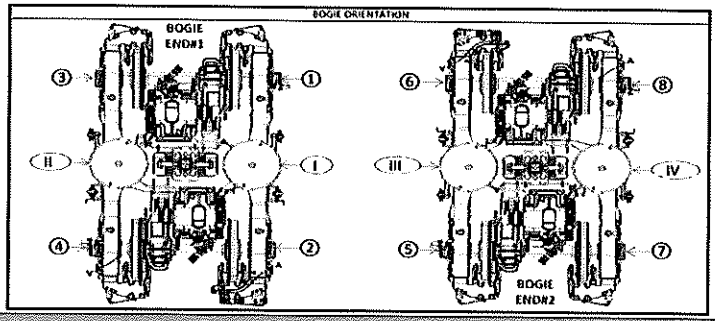
Weighting report from Test and Commissioning (Final measurements after Levelling and Weighting fine)
