# SELF INSPECTION SHEET

TUE	CAR	OPERATOR NAME	DATE	SELF INSPECTION NUMBER	PAGES
TS228	M3	Fikile MBONANI	13/05/2024	SI.FT1040.22	01/08

SELF INSPECTION INDUSTRIAL QUALITY	Rev. 02 DATE- 2022/06/22	Project: PRASA	SI.FT1040.22

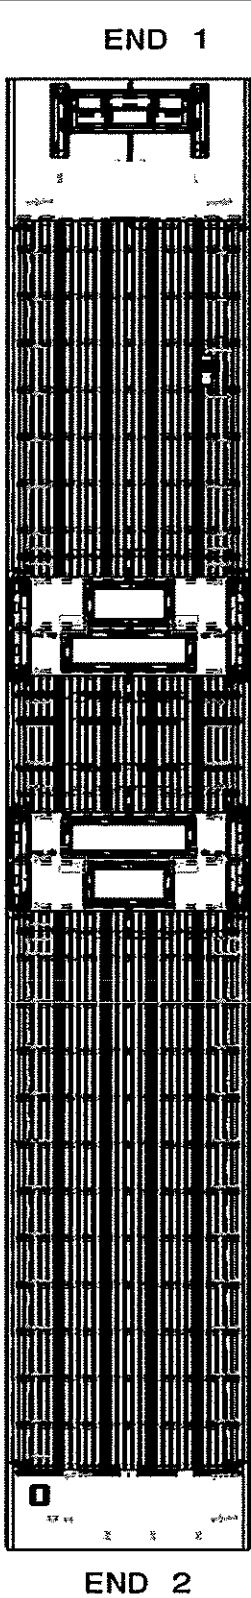
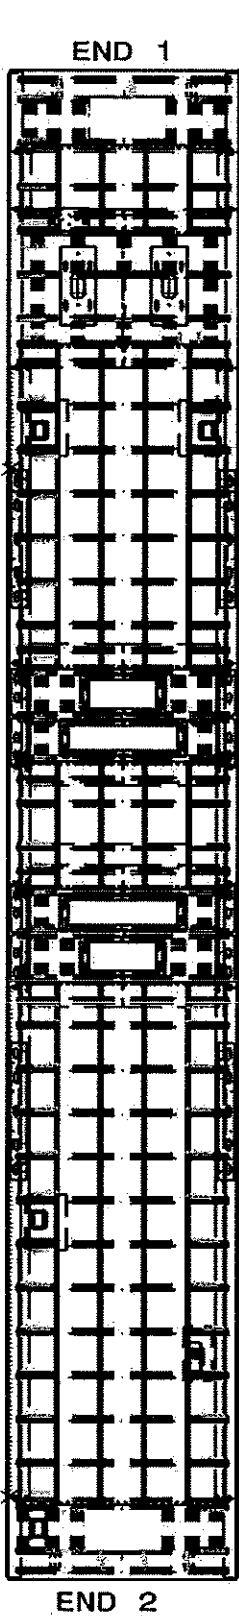
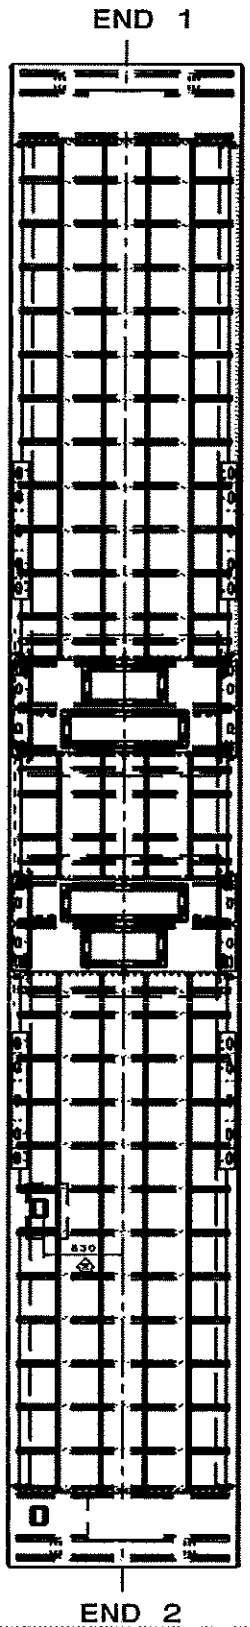
<b>SELF INSPECTION INDUSTRIAL QUALITY</b>		Rev. 02	Project: PRASA	SI.FT1040.22
				DATE- 2022/06/22		
ITEM	NP Leakages	Description/leakages and correction of action	OK			Signature/Date
11	1	LEAK ON RIGHT LATERAL WINDOW.

RHS LATERAL WINDOW LEAK , ~~NEEDS~~ SEALANT NEEDS TO BE RE-APPLIED.
