SELF INSPECTION SHEET

TUE	CAR	OPERATOR NAME	DATE	SELF INSPECTION NUMBER	PAGES
TS22S	TC2	FIRILE MBONANI	09/05/2024	SI.FT1040.22	01/08

<h2 style="margin: 0;">SELF INSPECTION INDUSTRIAL QUALITY</h2>	Rev. 02	Project: PRASA	<h1 style="margin: 0;">SI.FT1040.22</h1>
		DATE- 2022/06/22

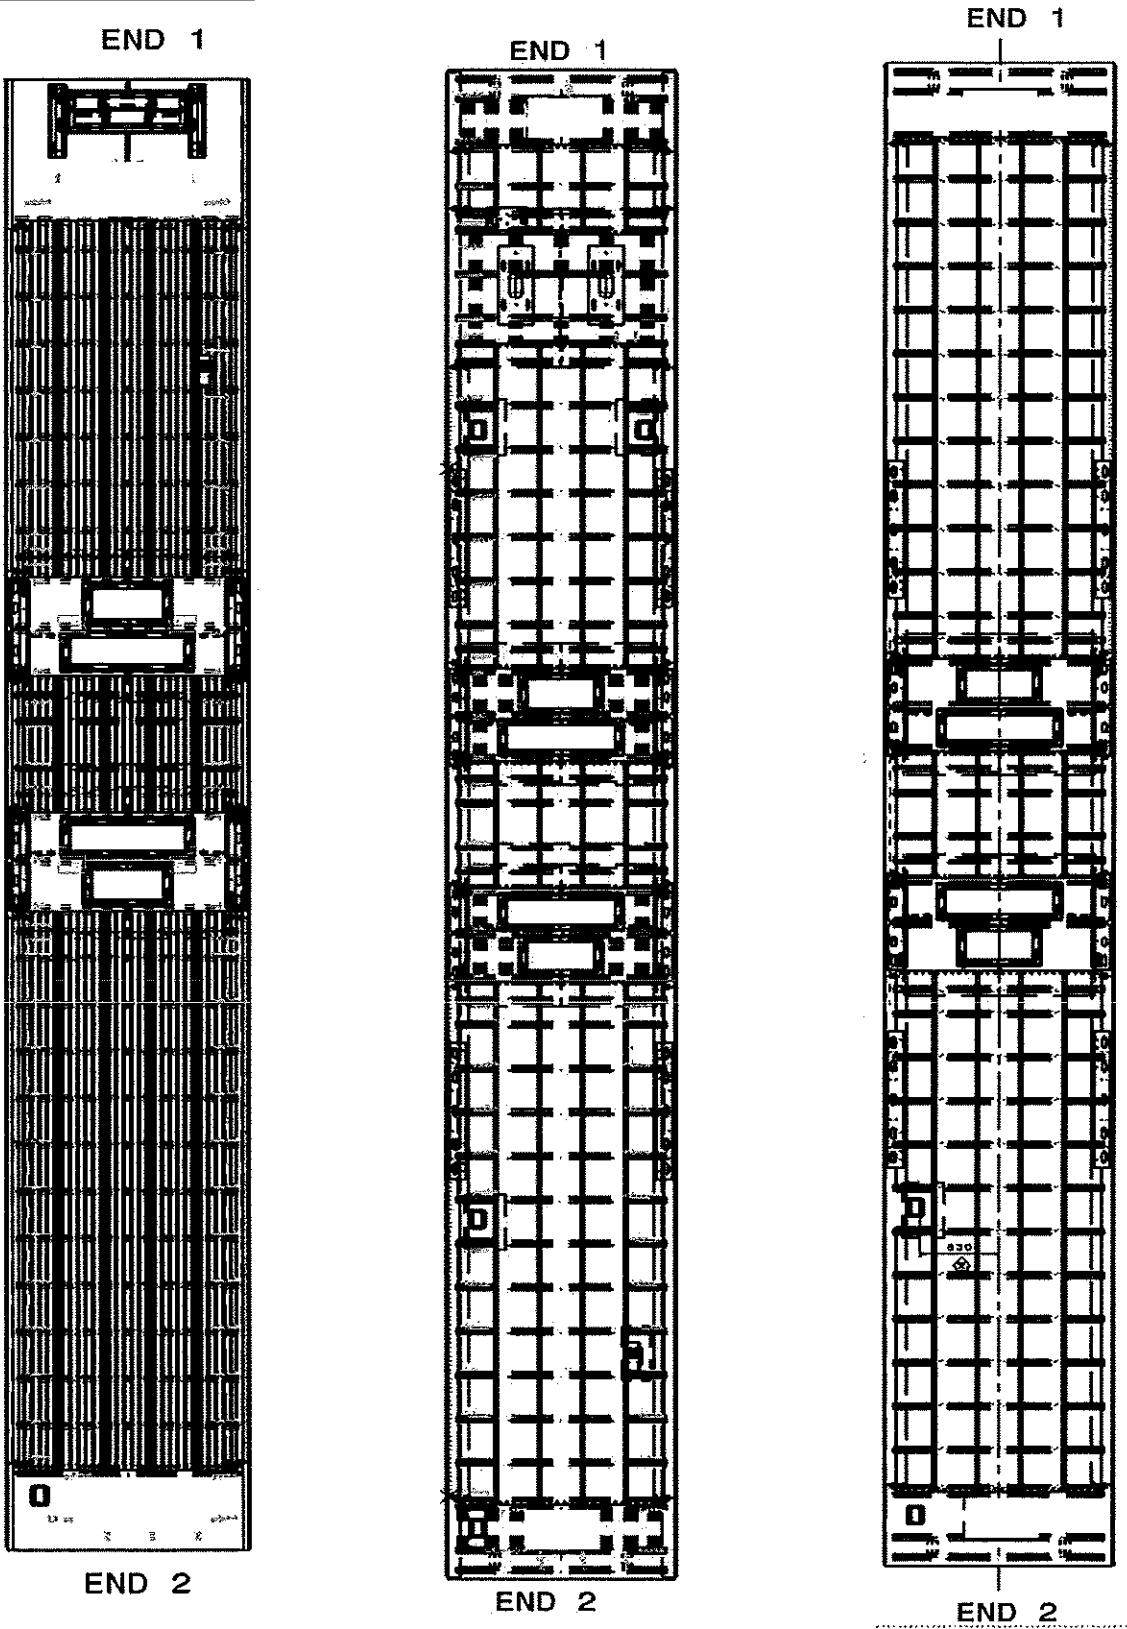
SELF INSPECTION INDUSTRIAL QUALITY		Rev. 02 DATE- 2022/06/22	Project: PRASA	SI.FT1040.22
ITEM	DP LeafPages	Description (leakages and corrective action)	OK			Signature/Date
11	1	RHS & LHS CAB DOORS LEAKING.				
		CORRECTIVE ACTION IS TO RE-ALIGN DOOR				
		AND ALSO ALIGN / STRAIGHTENING CAB				
		STRUCTURE.	✓
