SELF INSPECTION SHEET

TC1	M4	M1	M2	M3	TC2		
<input checked="" type="checkbox"/>	DTR3-PROCE-06	INTERNAL WATERTIGHTNESS	FT1040	1	1	1	1	X	1	PRA.FT1040.05.V6	NO
<input type="checkbox"/>											
<input type="checkbox"/>											
<input type="checkbox"/>											
<input type="checkbox"/>											
<input type="checkbox"/>											
<input type="checkbox"/>

TUE	CAR	OPERATOR NAME	DATE	SELF INSPECTION NUMBER	PAGES
TS231	M3	FUKILE MBONANI	11/06/2024	SI.FT1040.22	01/08

<h2 style="margin: 0;">SELF INSPECTION INDUSTRIAL QUALITY</h2>	Rev. 02	Project: PRASA	<h1 style="margin: 0;">SI.FT1040.22</h1>
		DATE- 2022/06/22

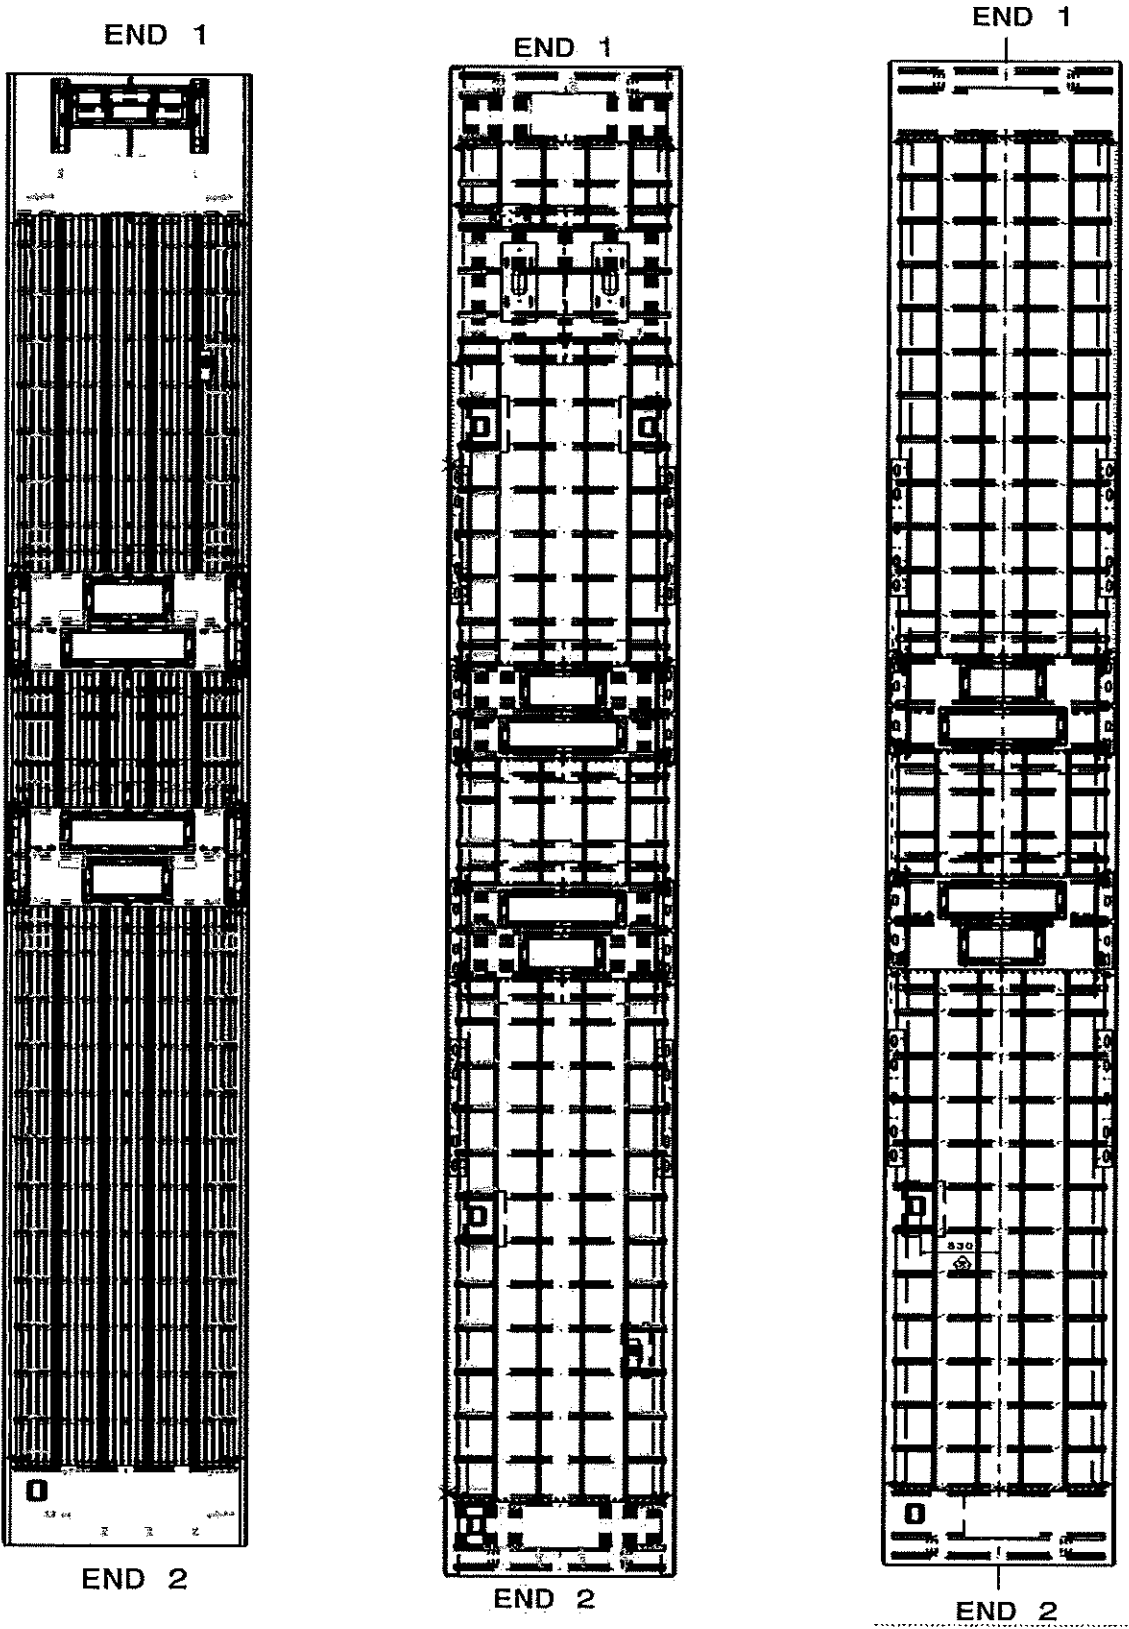
M3 and M4

SELF INSPECTION INDUSTRIAL QUALITY		Rev. 02	Project: PRASA	SI.FT1040.22
				DATE- 2022/06/22		
ITEM	Nº Leaks	Description leakages and correction of action	CIC			Signature/Date
11		WATER LEAK ON PASSENGER DOOR 3

WATER LEAKS ON UPPER GUIDE RAIL BOLTS ON DOOR 3 & DOOR 5.

Item	Description	Action	Responsible	Due Date	Status
1	leak on upper guide rail Bolts door 3 and door 5	remove detached sealant and re-seal	Mpusana	12/06/24	Closed
