SELF INSPECTION SHEET

TUE	CAR	OPERATOR NAME	DATE	SELF INSPECTION NUMBER	PAGES
TS 233	M2	FIKILE MBONANI	20/06/2024	SI.FT1040.22	01/08

<h1 style="margin: 0;">SELF INSPECTION INDUSTRIAL QUALITY</h1>	Rev. 02	Project: PRASA	<h2 style="margin: 0;">SI.FT1040.22</h2>
		DATE- 2022/08/22

Work station: FT1040

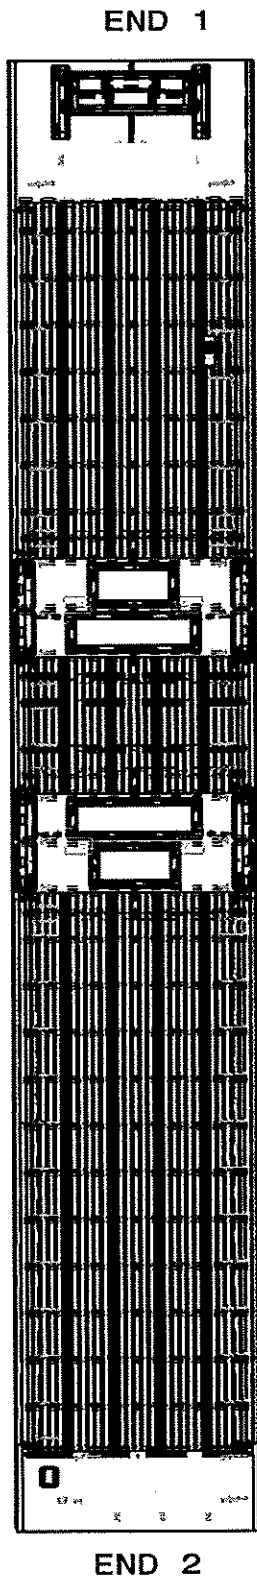
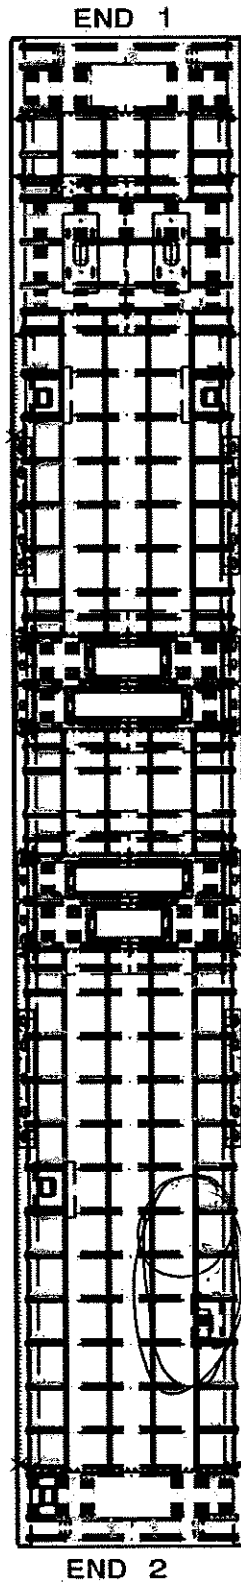
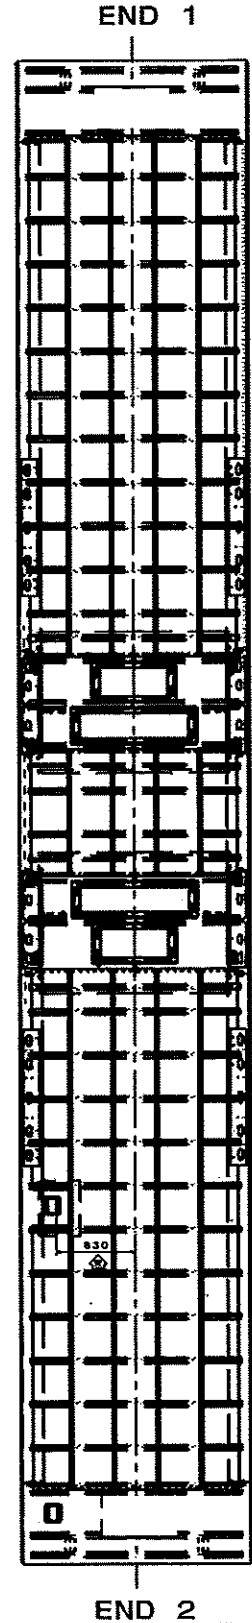
SELF INSPECTION INDUSTRIAL QUALITY		Rev. 02 DATE- 2022/06/22	Project: PRASA	SI.FT1040.22
ITEM	Nº Leaks	Description leaks and correction of action	OK			Signature/Date
11	1	LEAK FROM THE ANTENNA PLATE, NEEDS TO APPLY SEALANT ON PLATE TO COVER OPEN GAP	✓

Item	Description of the Issue		Signature/Date
1	LEAK ON ANTENNA PLATE	✓

In case of "NO GO", describe blocking problems					
LEAK ON ANTENNA PLATE FROM THE ROOF., NEEDS RE-APPLICATION OF SEALANT ON THE PLATE.					
In case of "NO GO", the operations manager must define below action plan to ensure "GO":
